1. Report No.	2. Government Accession No.	3. Recipient's Catalog No.	
4. Title and Subtitle Alkali Silica Reaction Mitigation & Prevention Measures-Phase I		5. Report Date December 2016

Abstract

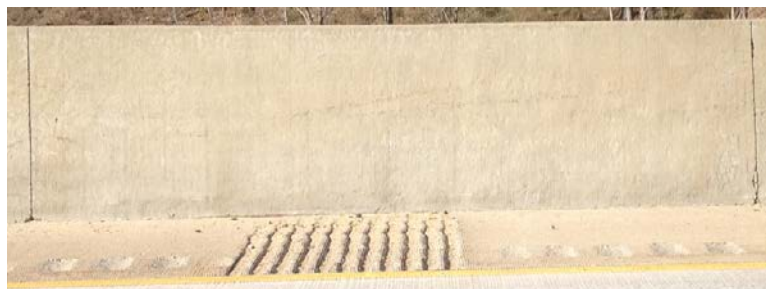
Fig. 3.1-1 Barrier wall section minimal deterioration, (e.g. no visible map cracking).

In August 2012 a visual inspection of the barrier was conducted to determine the extent of deterioration along the wall and to classify sections of the wall into deterioration categories. Three deterioration categories were selected based on visual symptoms of deterioration. Minimal deterioration was noted in the majority of the wall, which exhibited minor map cracking. A typical section of minimal deterioration is shown in section Fig. 3.1-1. There were 3.7 km (2.3 mi.) of the wall categorized with minimal deterioration.

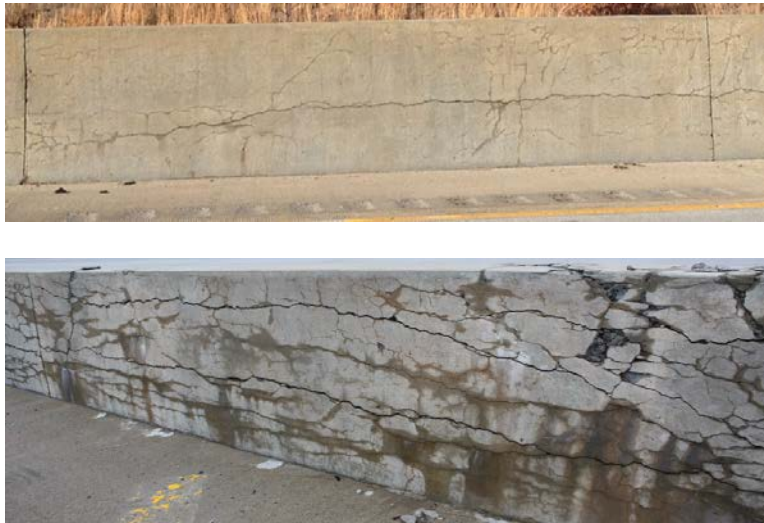
Fig. 3.1-2 Barrier wall section moderate deterioration, (e.g. moderate visible map cracking, and a longitudinal crack along the full length of the section) (Top). Barrier wall section severe deterioration, (e.g. severe map cracking, longitudinal cracks, crushing at the joints, and visible alkali-silica gel exudation) (Bottom).

A typical section with moderate deterioration is shown in Fig. 3.1-2 (Top), which exhibits map cracking and longitudinal cracks parallel to the internal restraint. The wall is expanding vertically, due to the lesser restraint in the vertical direction as compared to the longitudinal direction which

is restrained externally and internally. There were 2.25 km (1.4 mi.) of wall that exhibited moderate deterioration. Several sections of the wall had severe deterioration with map cracking, multiple longitudinal cracks, crushing and alkali silica gel deposits on the surface. There were 1.13 km (1.4 mi.) of wall with severe deterioration a typical section with severe deterioration is shown in Fig. 3.1-2 (Bottom).

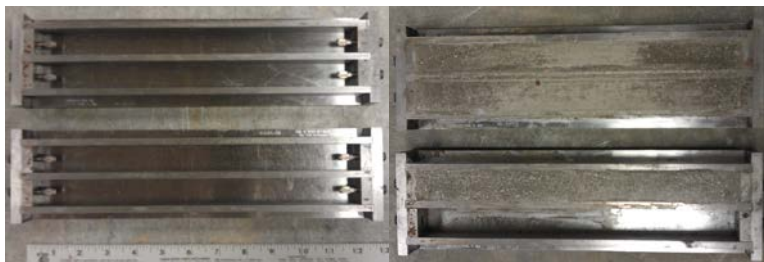
Fig. 3.2-1 Mortar-Bar mold with gage studs (left) and mortar-bar mold with three mortar-bars (right).

The standard batch produced enough mortar for three mortar-bars with standard dimensions of 25 x 25 x 285 mm (1 x 1 x 11.25 in). The mortar bars were cured for 24 hours in an environmental chamber with ambient temperature of $23 \pm 2^\circ \text{C}$ and 95% RH. The mortar-bar molds are displayed in Fig. 3.2-1 (left), and typical cured mortar-bars are displayed in Fig. 3.2-1 (right).

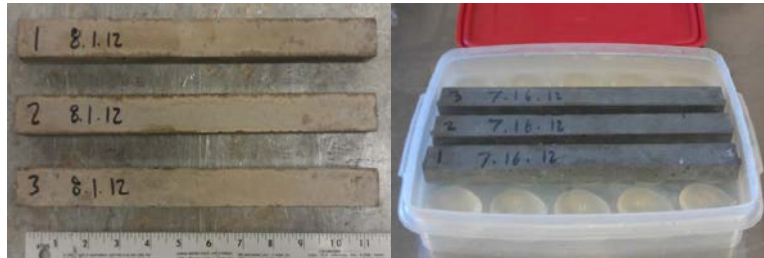
Fig. 3.2-2 Mortar-bars (left) and mortar-bar in storage container (right).

3.2-2 (left), and a typical set of mortar-bars in the storage containers are displayed in Fig. 3.2-2 (right).

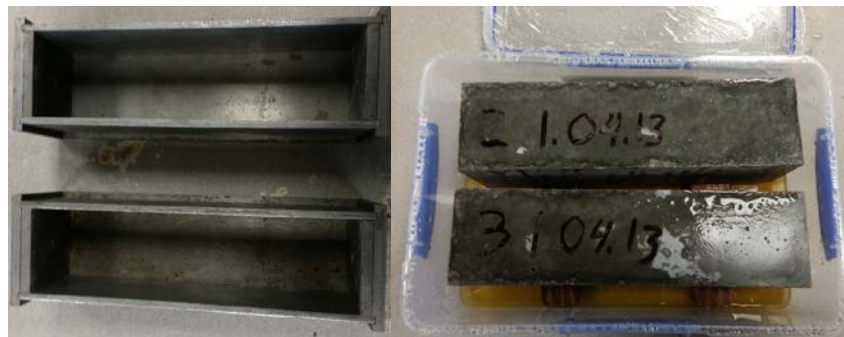
Fig. 3.2-3 Typical CPT prism molds (left), and storage containers (right).

After curing, the prisms were removed from the molds and the initial length-change was measured using a length-change comparator with a digital gage. The prisms were then placed in the storage containers and placed in a water bath at 38° C. The duration of length-change monitoring was one year, with interim readings taken at 7, 28, 56 days, 3, 6, 9, and 12 months. The storage containers were removed from the water bath 16 ± 4 hours before length-change readings to allow the temperature of the prisms to equilibrate to room temperature. The storage containers must also maintain a high RH (ASTM, 2012). The containers used for storage had dimensions of 225 x 300 x 112 mm (9 x 12 x 4.5 in.) with a water tight cover. The prisms were elevated 25 mm (1 inch) from the bottom of the container with small blocks of wood, and then 12.5 mm (1/2 inch) of water was placed in the bottom of the container. The containers were sealed and placed in a water bath to maintain a temperature of 38° C.

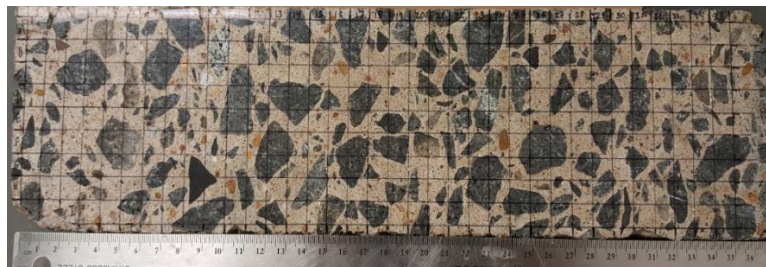
Fig. 3.2-4 Typical prepared DRI sample with grid.

inspection procedure involves placing each grid square within the view finder of the stereo microscope. A magnification of 15x provides a viewable area roughly the same size as a 1 cm square. The square is then inspected for petrographic features, and the features recorded on a spreadsheet. Petrographic features of interest were counted and multiplied by the weighing factors proposed by Sanchez (2014). The list of features is included in Table 3.2-3. The total features present within the sample were then normalized to a surface area of 100 cm², and this number reported as the DRI.

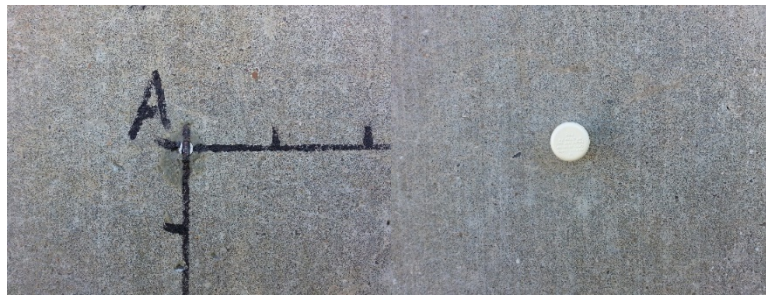
Fig. 3.3-2 Typical gage stud (left) and humidity port with cap (right).

Stainless steel gage studs were machined with dimensions of 8 mm (5/16 inch) diameter by 75 mm long. A small point (1 mm by 3 mm deep) was drilled into the end of the gage stud. The points on the DEMEC gage were inserted into the points in the gage studs when measuring the distance between two gage studs. A gage stud which was affixed to the median barrier is shown in Fig. 3.3-2 (left) and a humidity port is shown in Fig. 3.3-2 (right).

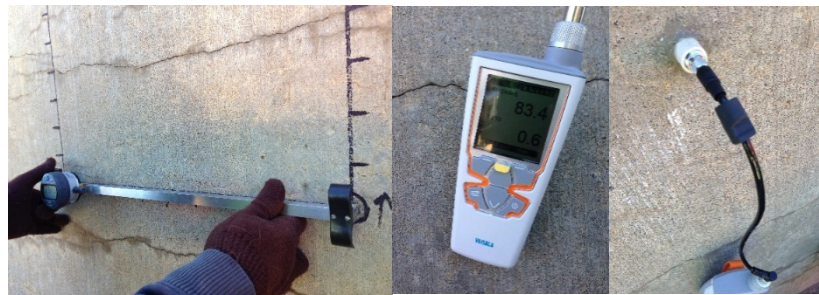
Fig. 3.3-3 DEMEC gage during length-change measurement (left), portable humidity indicator (center), and humidity probe inserted into a humidity port (right).

removed for measurements and was intended to prevent moisture from entering or exiting the port. During measurements, the humidity probe was inserted into the port and allowed to equilibrate with the concrete for 30 minutes. The probe was left in the port until there was less than $\pm 1\%$ change in internal RH over a five-minute period, but no less than 15 minutes total time. Ideally, one hour was required to allow the conditions within the port to reach equilibrium with the concrete. However, time was limited and only 30 minutes was available to measure each median barrier section. In addition, because the ports were sealed before measurements were taken; the ambient conditions within the port were already in equilibrium with the concrete. Once the humidity probe was inserted into the port and the temperature of the probe reached equilibrium with the concrete no additional time was required for equilibrium to occur. After the probe temperature reached equilibrium with the concrete, subsequent sections took less time because no additional time for equilibrium conditions was required. The portable humidity indicator and humidity probe are shown in Fig. 3.3-3 (center) and Fig. 3.3-3 (right), respectively.

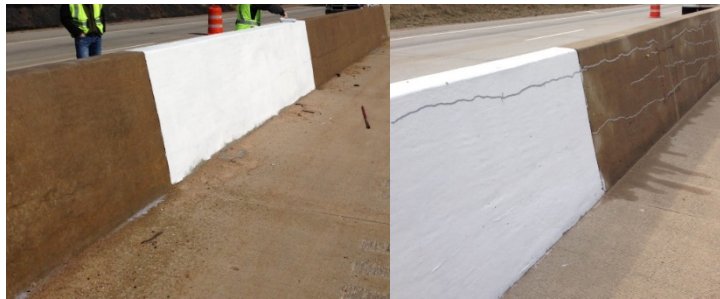
Fig. 3.3-4 Application of surface treatment (left) and crack sealant (right).

There were five sections of median barrier selected for treatment from each of the three deterioration levels. The first section was left untreated as a control, the second section was sprayed with a single application of silane, the third section was sprayed with a single application of linseed oil, the fourth section was painted with elastomeric paint, and the fifth section was sprayed with a single application of silane and then an additional application of silane six months later. A typical application of surface treatments is shown in Fig. 3.3-4 (left). To ensure the correct application rate, the required amount of each respective treatment for a single section was measured and then applied to the section. The sections were allowed to dry for 24 hours, and then initial length-change and internal RH were measured. Several of the moderately and severely deteriorated sections exhibited wide cracks (> 2 mm) which were sealed with silicon sealant to prevent excess moisture from entering the concrete. The silicon crack sealant is shown as applied in Fig. 3.3-4 (right).

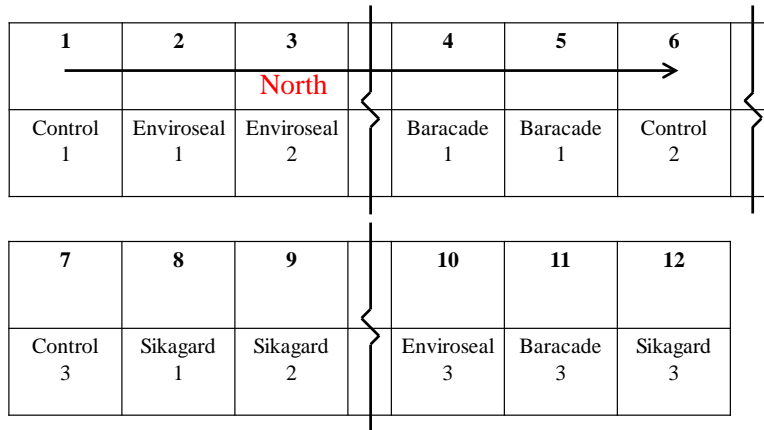
Figure 3.4-1. Pavement treatment location and numbering.

Each of the twelve instrumented panels were treated with one of the selected silanes in March, 2014. The panels were treated the same day as instrumentation. The silanes were selected from different manufacturers that are readily available in the United States. Each silane was applied by spraying, using a hand operated pressure canister. The application rate was regulated by applying a predetermined volume of silane to each panel, based on the surface area of the panel. The silane was applied consistently over the surface area until a thin film of excess material was on the entire surface. The commercial brand name, application rate, and composition are summarized in Table 3.4-1. Of the twelve pavements panels, three remained untreated as controls. Each silane treatment was applied to three panels over the test section. The manufacturer recommended dosage was 3.7 m²/L (150 ft²/gal), and 6.1 m²/L (250 ft²/gal) for the 40% and 100% silane solutions, respectively. Two of the silanes were 40% silane by solution and the remaining silane was 100%. The 40% silane solutions are alkylalkoxysilane water emulsions, while the 100% solution is 100% alkyltrialkoxysilane in methanol solution. The silanes were applied to the panels as summarized below in Fig. 3.4-1.

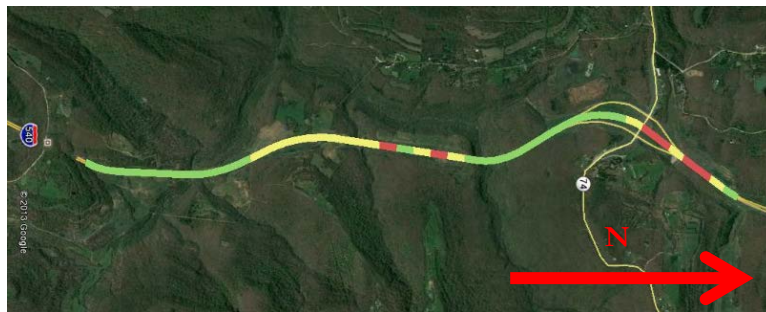
Fig. 4.1 Median barrier deterioration level along Interstate 49. Figure produced in Google Earth.

Deteriorated Sections (Miles)			
Minimal	Moderate	Severe	Total
2.3	1.40	0.7	4.40

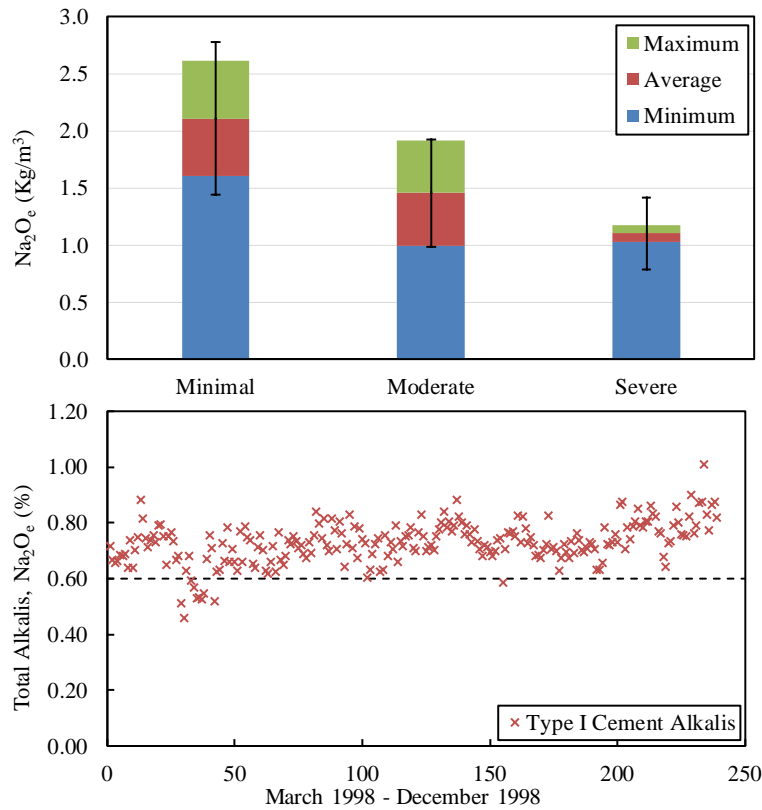
Fig. 4.1-3 Alkali concentration Na_2O_e (kg/m³) (Top). Historic alkali concentration of cement Na_2O_e (%) (Bottom).

the pore solution during hydration was 4.1 kg/m³. This concentration is higher than the recommended limits and likely contributed to the formation of ASR.

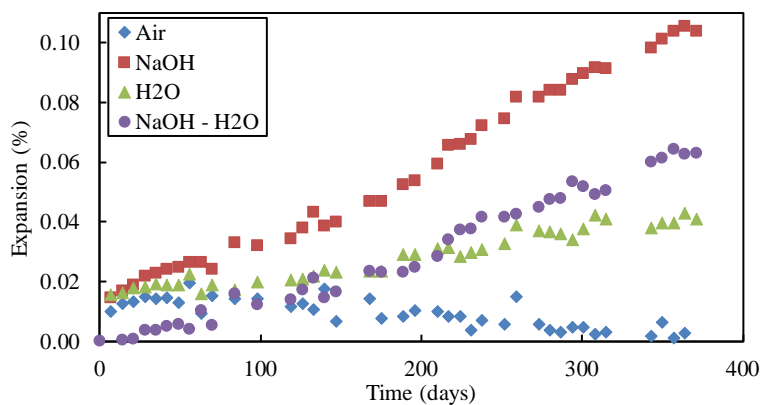
Fig. 4.1-4 Potential for further expansion in concrete pavement.

indicating that there are limited alkalis remaining in the concrete, preventing ASR products from forming. The samples stored in water, adsorbed water and expanded due to saturation. The results were then subtracted from the expansion of the samples stored in NaOH. The NaOH-H₂O results indicate the potential free expansion that could occur in the concrete if sufficient alkalis were available. However, the results from samples stored in air indicate that no additional expansion will occur in the field due to a lack of soluble alkalis. Additional core samples were extracted from the pavement two years after treatment and the samples will be sent for pore solution expression and analysis to determine the soluble alkalis within the concrete.

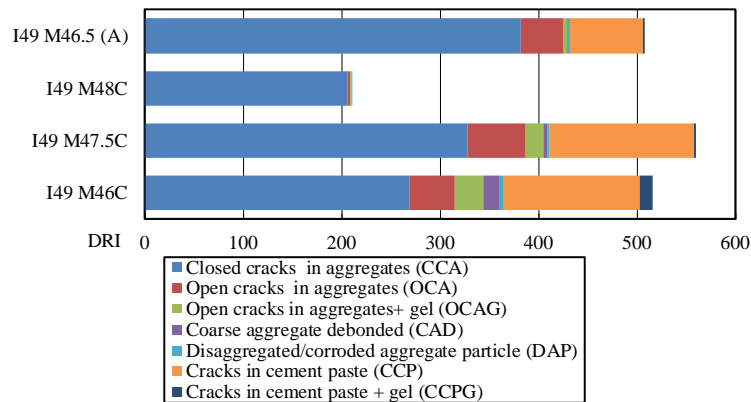
Fig. 4.1-5 Deterioration rating index (DRI) results for core samples from I49 (pretreatment).

One of the core samples from the PFE testing was also prepared for DRI analysis. The core had been exposed to ASR accelerating conditions for one year. The core was from LM 46.5 (I49 M46.5 (A)), and the core showed an increase in closed cracks in the coarse aggregate after one year. However, the core did not expand during this exposure period, and indicates that additional cracking in the coarse aggregate is due to existing cracks in the concrete which are propagating from the cement paste and through the coarse aggregate.

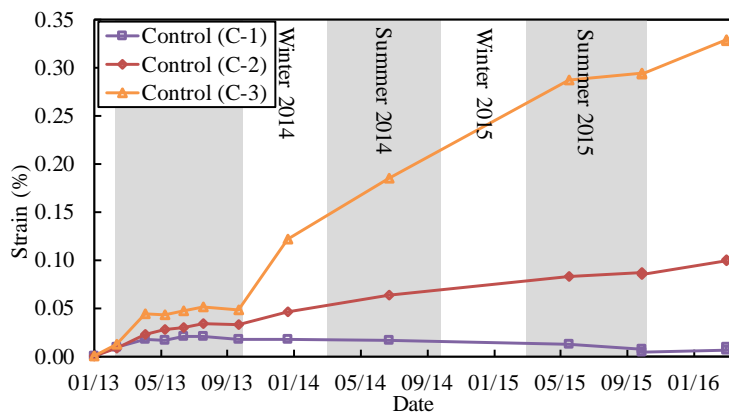
Fig. 4.2-4 Strain (%) with respect to time (days) for barrier wall control sections, with seasons highlighted to indicate the increase in strain rate over winter months.

A summary of the control strains for sections of minimal, moderate, and severe deterioration is provided in Fig. 4.2-4. The plot is divided into winter and summer seasons, which reveals the increase in strain rate over the winter months, and then decrease in the summer. This is counter intuitive, as ASR should accelerate during the warmer summer months. However, the increased deterioration over the winter is actually due to freezing and thawing strains, when moisture trapped within the concrete expands during freezing. The presence of ASR in the concrete causes cracks, which cause more moisture to enter the concrete leaving the concrete in a saturated state during freezing. In addition, ASR gel deposits fill air and capillary spaces, reducing the available volume were water normally escapes during freezing. These two factors reduce the freezing and thawing resistance of the concrete, leading to additional deteriorating in the winter.
